## Which RepairKit do i need

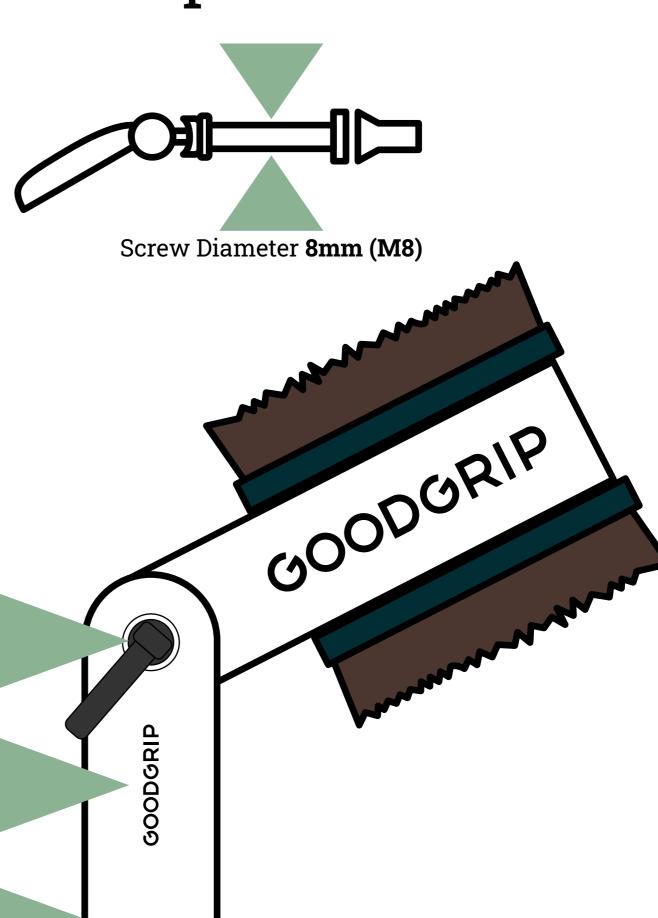
M6
Repair-Kit

Hole in the joint is **6,5 mm**

NO LOGO under the Quick Release

Production before 2022-09

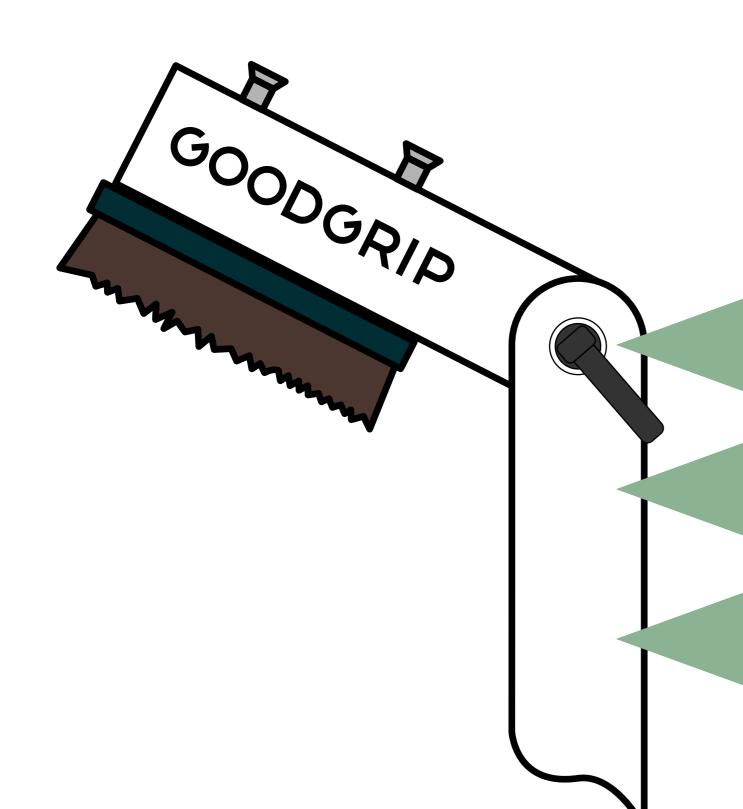
M8 Repair-Kit

Hole in the joint is **8,5 mm**

**Logo - Branding** under the Quick Release

Production after 2022-09
